Roanoke Rapids and Gaston Hydropower Project FERC Project No. 2009

FERC License No. 2009 Roanoke Rapids, NC

AEWG Eelway Effectiveness Studies

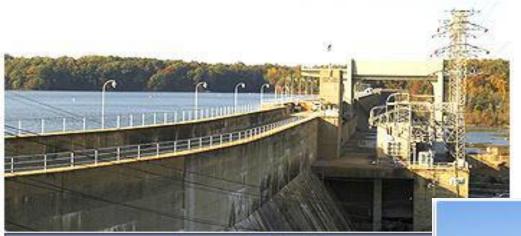
• Built in 1964

• 32 m high dam

220 MW
